RAILWAY ACCIDENT INVESTIGATION REPORT

Occurrence of casualties among passengers of 7 up Tinsukia Mail train at Km./77/3-4
between Pathsala and Tihu Stations on the Single Line New
Bongaigaon Gauhati Metre Gauge Section of
Alipurduar Division of Northeast
Frontier Railway at
13-09 hours

12 th March, 1981

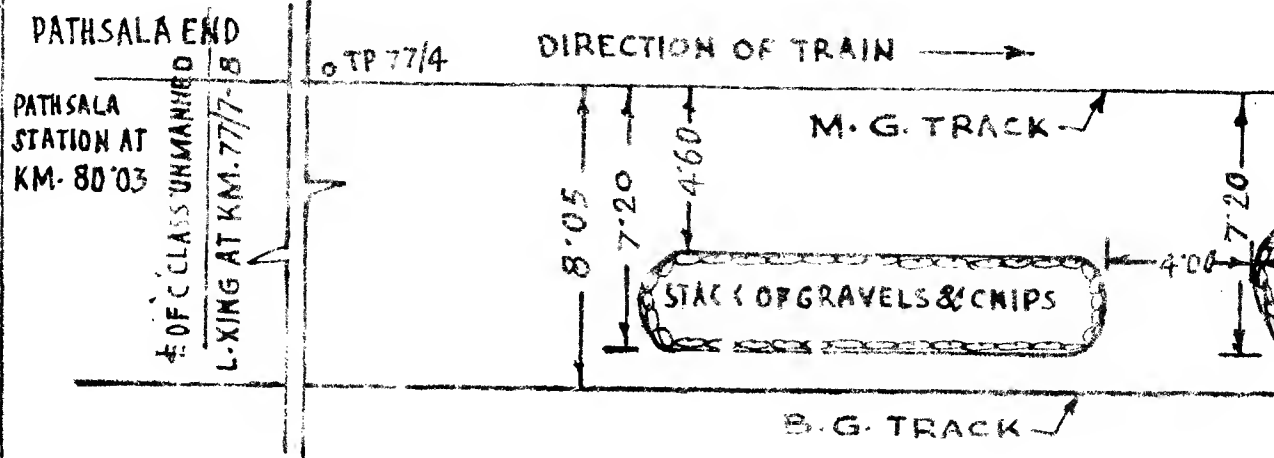
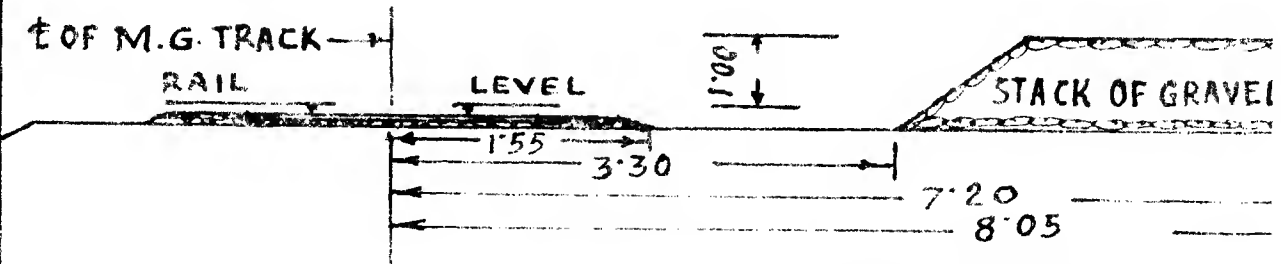
SECTION ON A-B
SCALE: - 2CM=1M.

6.1.2 It was explained by the Executive Engineer (Con) that when the earlier trips were unloaded in the presence of the IOW, the trucks were unloaded by stopping them about 60 metres short of the Bridge No. 483 and well clear of the line demarcated at 2.5 m. from the centre line of M.G. track. The unloaded material was then carried forward by manual labour and stacked. However the particular truck which caused the accident, having come there for a first time, seemed to have stopped in the 3.3 m. distance between the metre gauge track and the stacks already made.

6.1.3 It was stated by the Divisional Engineer that soon after the accident some wheel marks were found on the ballast shoulder of the metre gauge track at a distance of 1.5 metres from the centre line of the track. The truck standing in this position would have fouled the metre gauge track sufficiently to have been hit by the locomotive and to be smashed up. Therefore these marks should have been made while the truck came in before and went back soon after the accident.

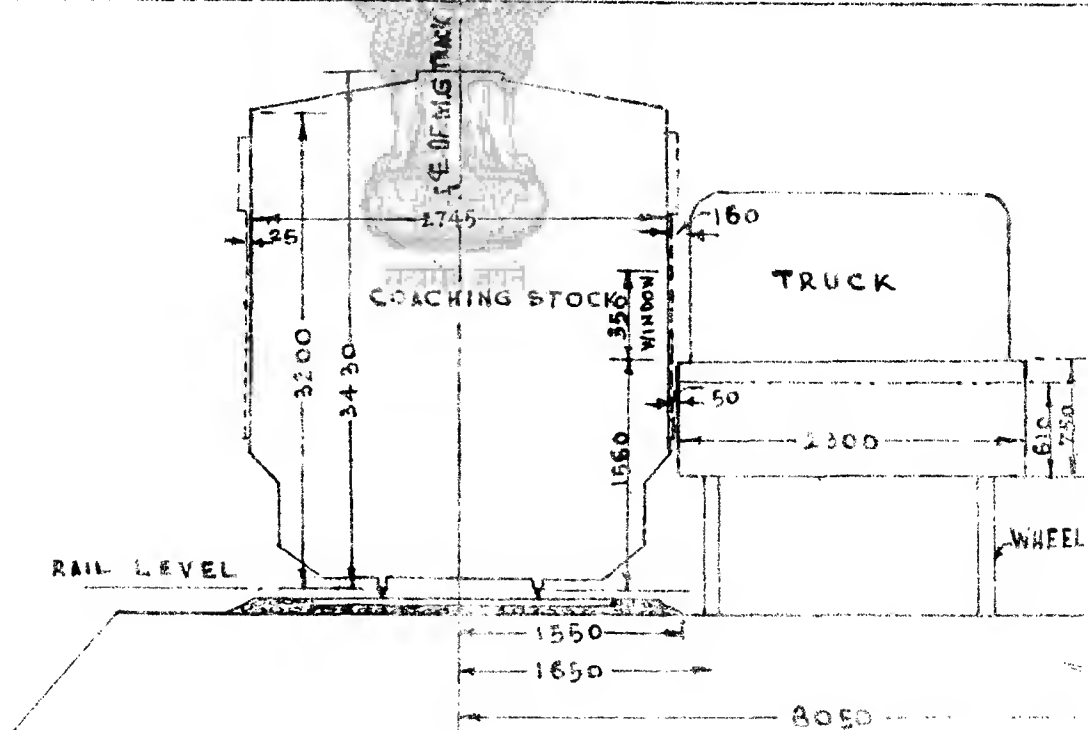
SECTION SHOWING PROBABLE POSITION OF COACH AT
AT THE TIME OF ACCIDENT.
SCALE - 2CM=1M.

In this position it was observed that the truck would be fouling the moving dimensions of the metre gauge track.

fouling the metre gauge track. In the present case the truck was close enough to cause injuries to passengers who had kept their limbs projecting outside the window but it was far enough not to come in contact with the body of the coach.
